# Banjo Axle Hub Repair Sleeves

Part Number: [Z150](#) - MGA & MGB

Part Number: [Z151](#) - MG Midgets

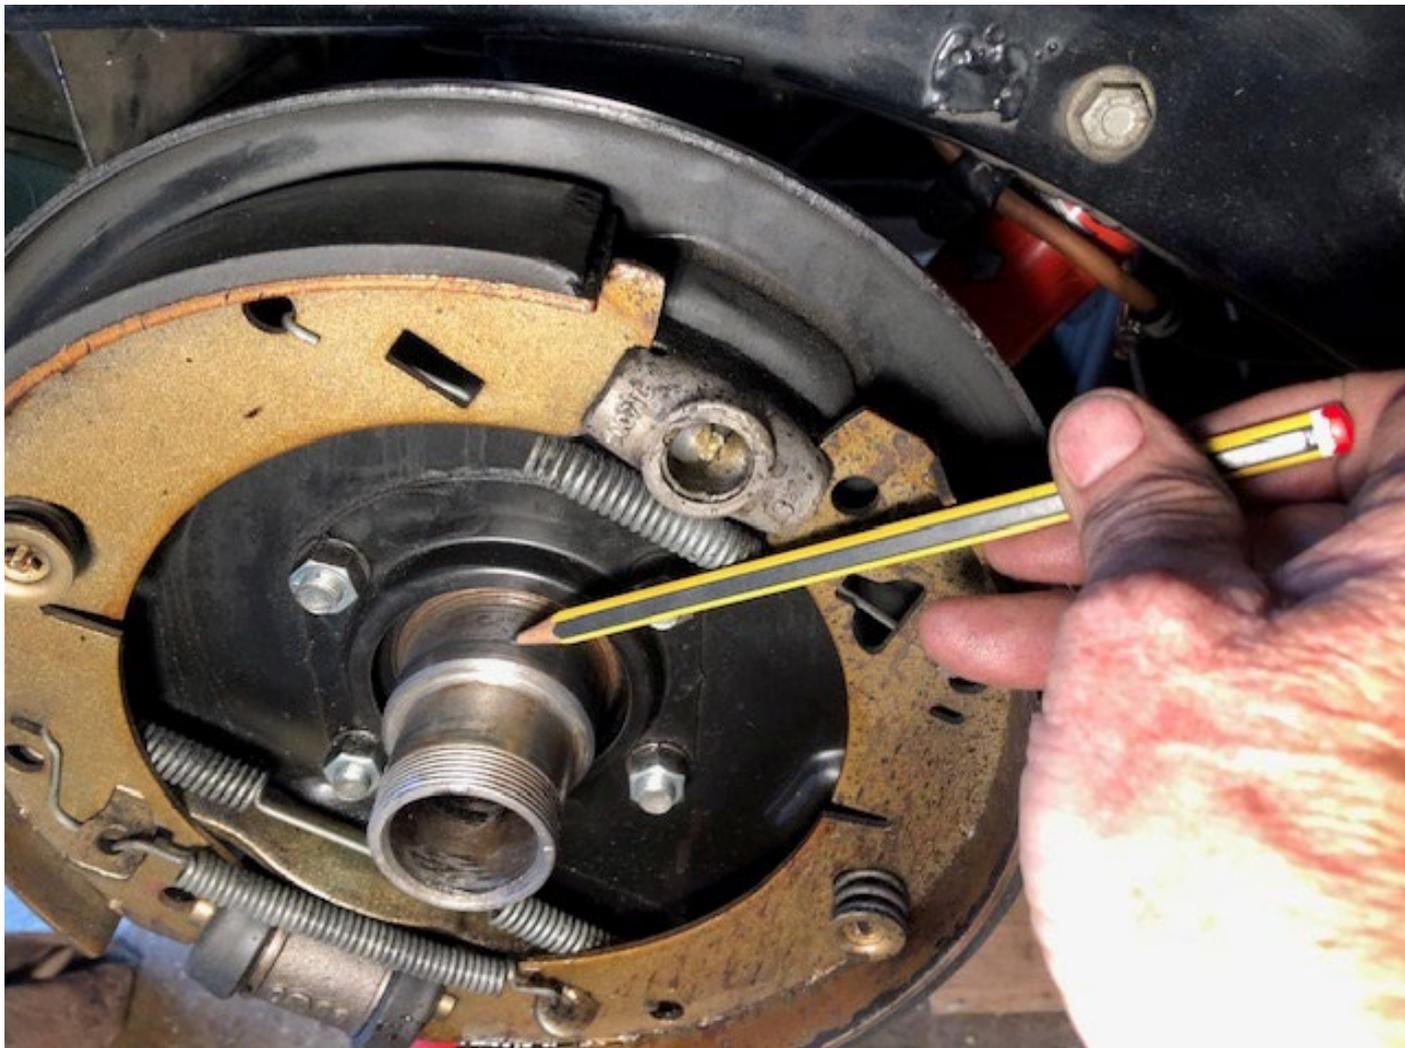
The photo below shows a grooved wear line around the journal on which the hub bearing oil seal sits. The worn surface allows oil into the brake drum area. The Speedi Sleeve provides a smooth surface on which the oil seal can rotate. If you cannot detect wear on the axle journal, check and replace the O Ring (MGA/MGB [ATB7354](#) & Midget [ATA7225](#)), the paper gasket (MGA & MGB [GFG115](#) & Midget [GFG110](#)) and the Oil Seal (MGA & MGB [GHS211](#) & Midget [GHS147](#)) inside the bearing housing). These items should be replaced and fitted correctly in any event when installing a Speedi Sleeve.

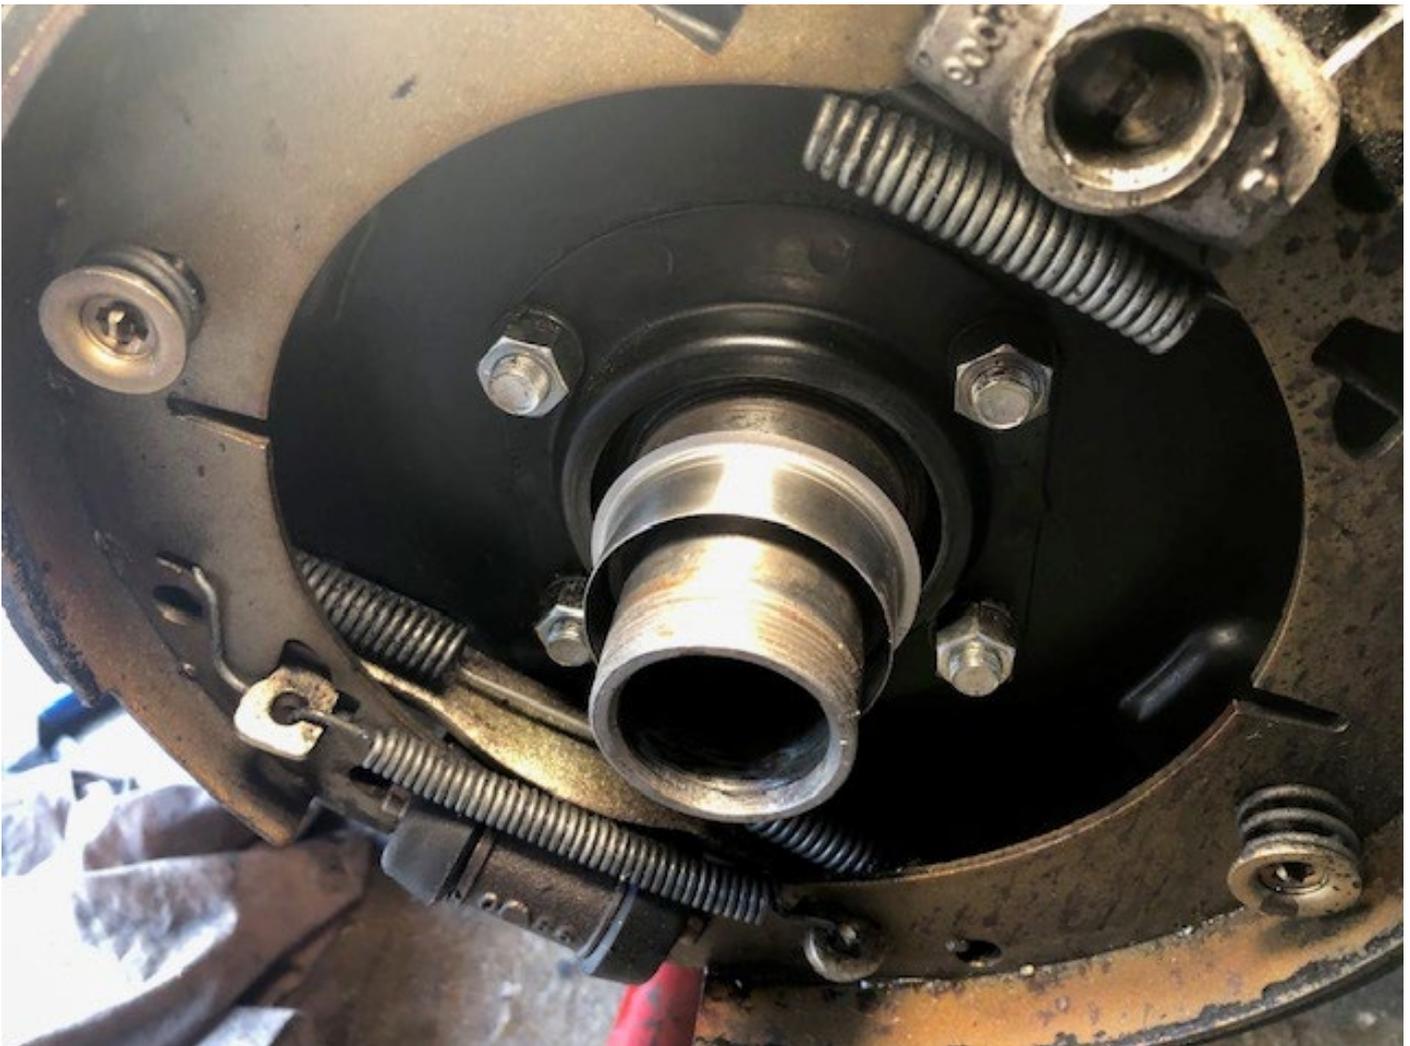
### Step 1

After thoroughly cleaning the journal start by gently easing the sleeve on. The saying “necessity is the mother of invention” couldn’t be truer in this situation because you will have to devise a tool that slides over the sleeve and presses against the upturned collar. I used a robust cooling hose with a large jubilee clip as strengthening support. A small piston ring compressor would also work well, but take care not to scratch or distort the surface of the Speedi Sleeve. Once the sleeve is eased on, apply a small amount of [Blue Hylomar](#) in the area between the axle housing and the sleeve to prevent internal leakage after installation.

**NB.** If the groove is substantial, it may be necessary to fill it with cold weld compound such as araldite or JB weld before fitting the Speedi Sleeve.

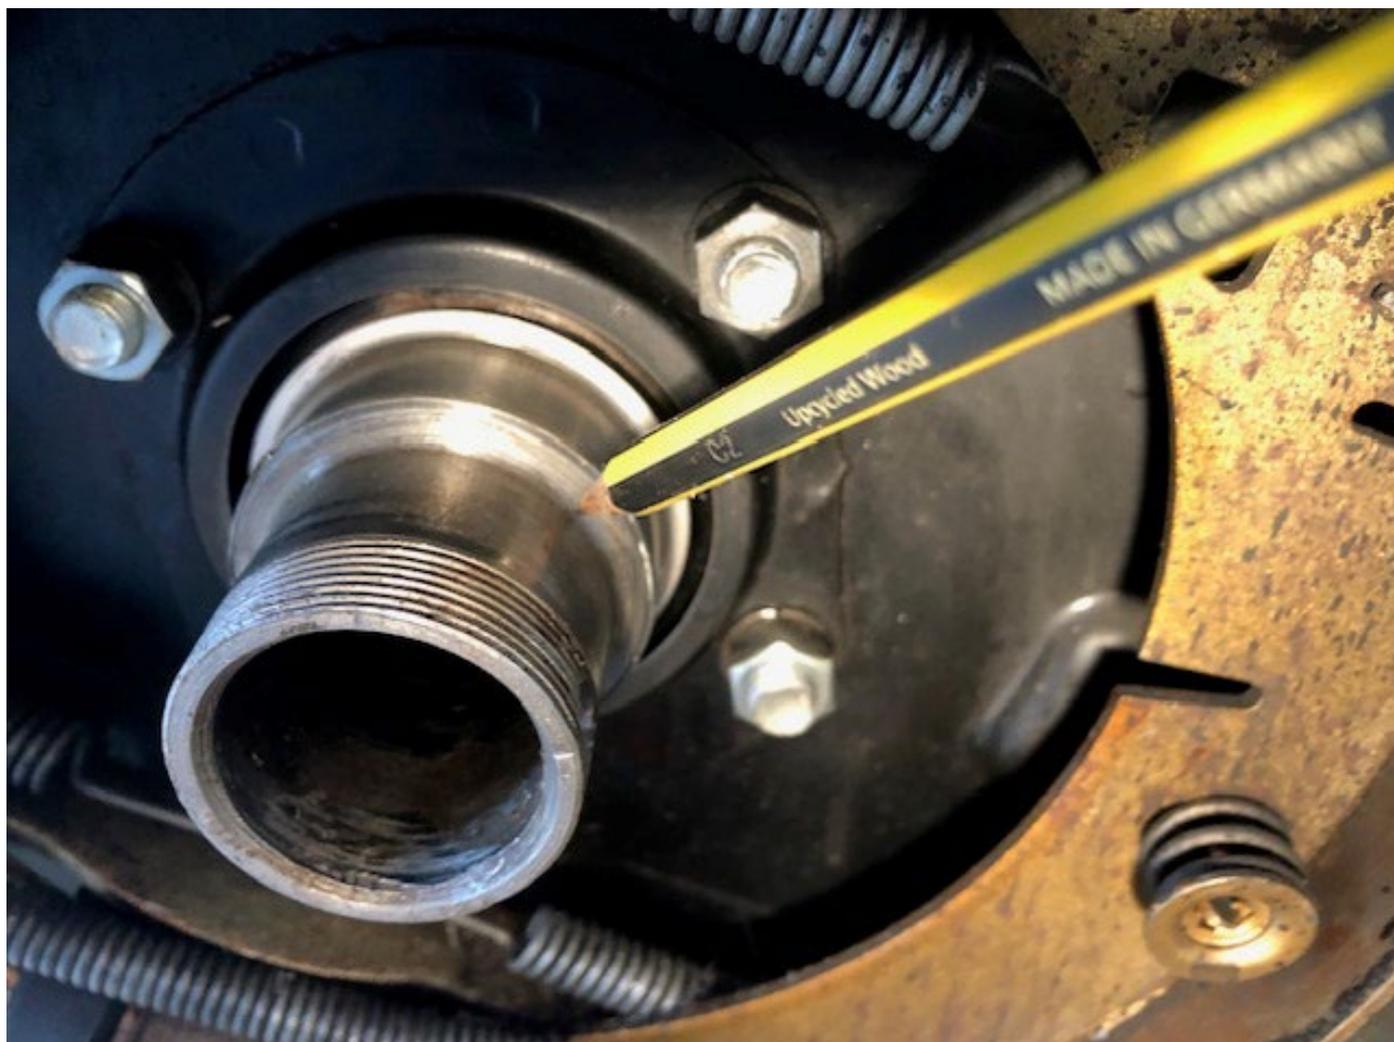
## Step 2

Being careful not to scratch or distort, drift with an appropriate device into position. The front edge of the sleeve needs to finish just behind the stepped section where the journal starts. The inner race of the hub bearing will press up against the step and must not foul the sleeve.

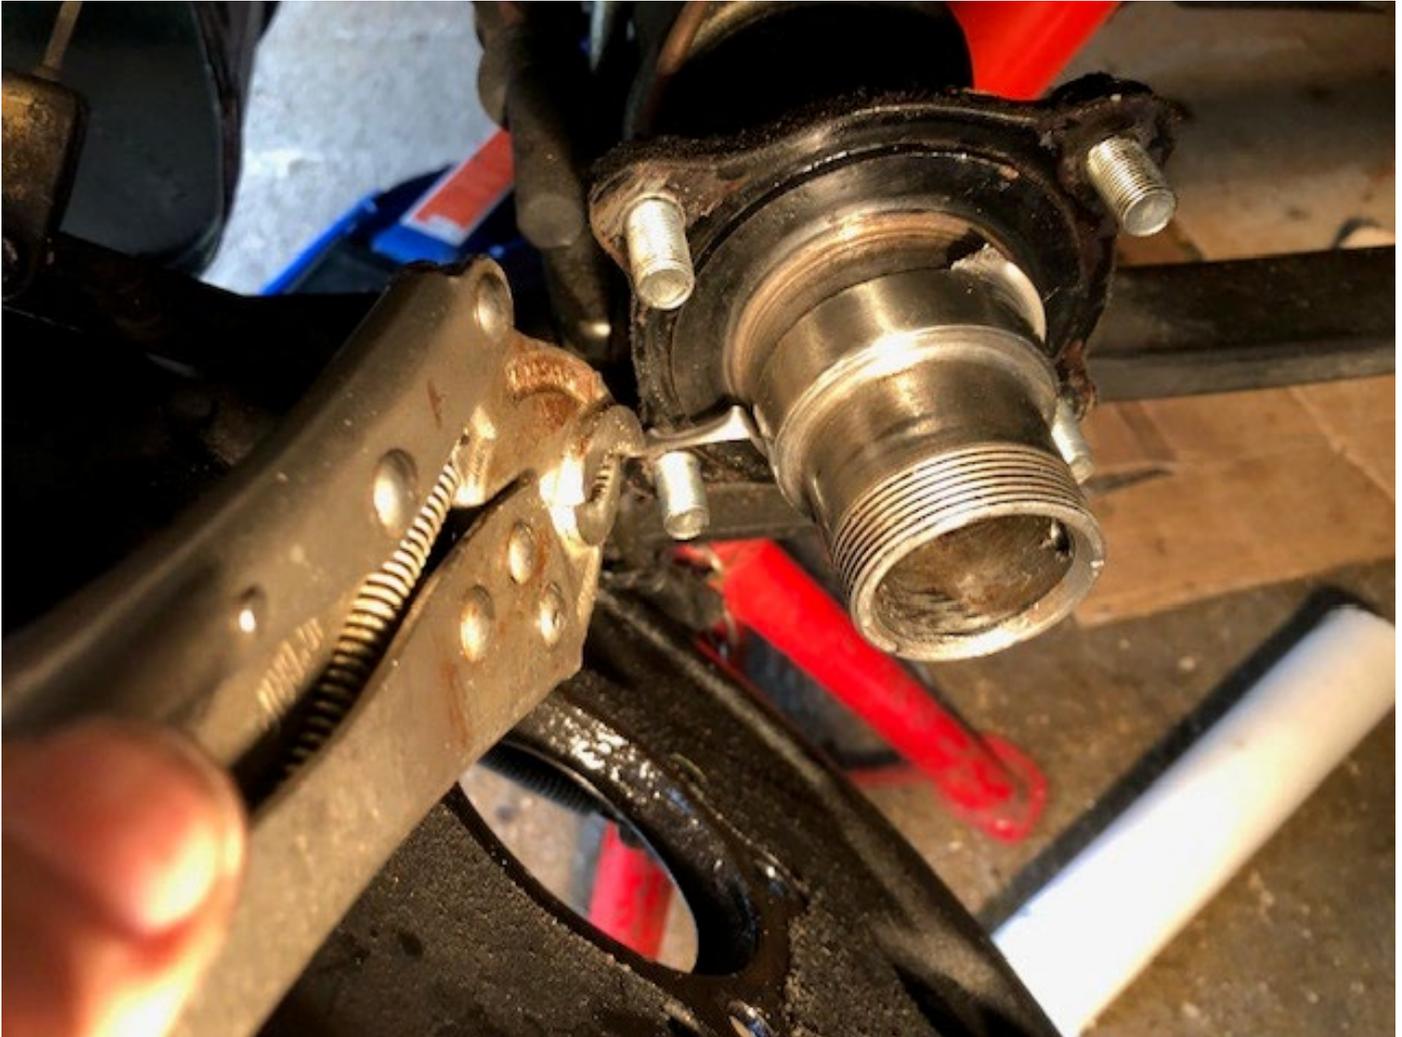
### Step 3

This shows the back edge (upturned collar) of the sleeve being removed in order not to obstruct the rotating hub. You will see that the backplate is now removed and this is to get access to the rear of the sleeve. Again, be careful not to scratch the sleeve! Using thin cutting pliers snip through the upturned collar, then with pliers pull the cut edge up with a twisting motion and the collar will break off along the perforated line.

The journal now has a smooth surface on which the new oil seal can rotate. Remember to apply some grease to the sleeve surface and to the new lip seal when assembling.

Also remember to renew the O ring, paper gasket and hub bearing seal.

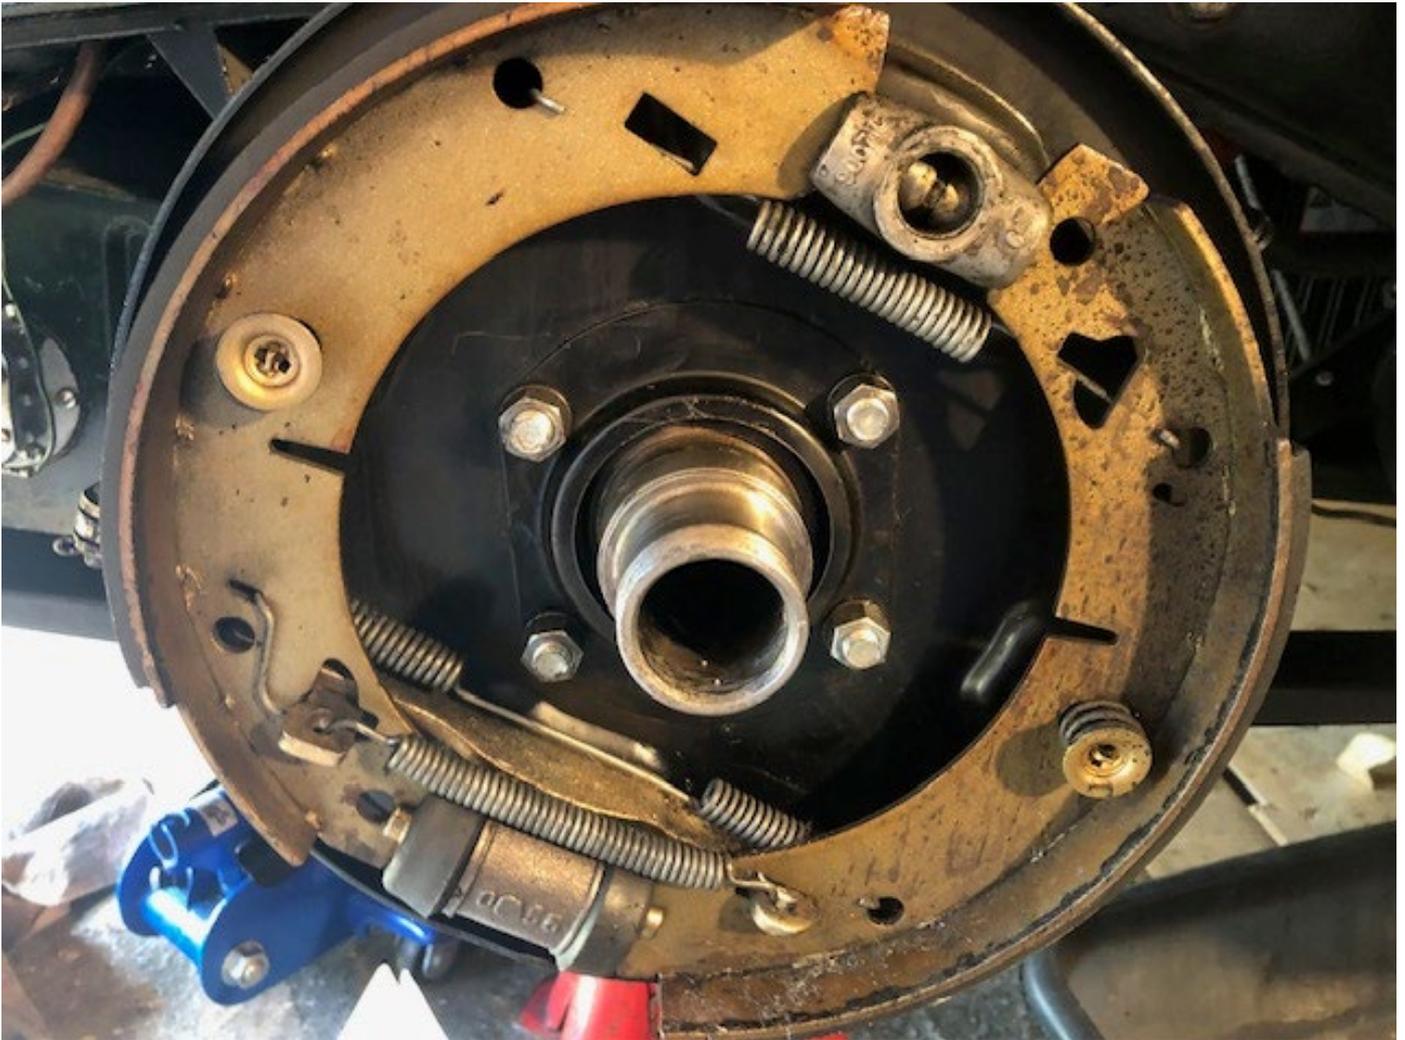
## Step 4

Speedi Sleeve repair complete. Check brake shoes for contamination and replace where necessary referring to the factory workshop manual.

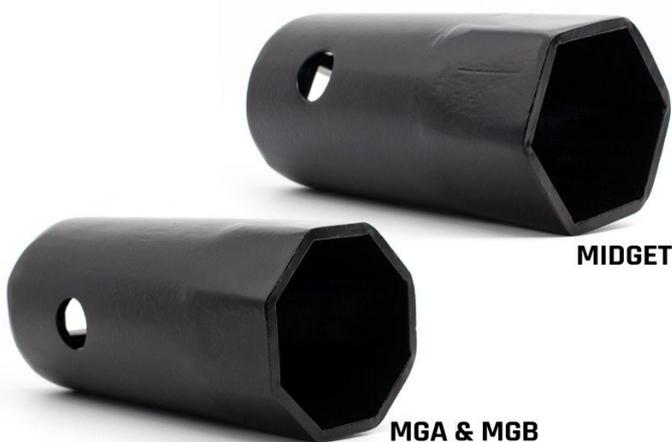
*Fig. shows Box nut hub spanners for servicing MGA/B ([18G152B](#)) & Midget ([18G152A](#)) hub assemblies*
